UNITED STATES  
NUCLEAR REGULATORY COMMISSION  
WASHINGTON, D.C. 20555-0001

November 18, 2020

SUBJECT: TECHNICAL REVIEW: U.S. DEPARTMENT OF ENERGY  
DOCUMENTATION RELATED TO TANK 12H GROUTING  
OPERATIONS WITH EMPHASES ON SPECIFICATIONS, TESTING,  
RECOMMENDATIONS AND PLACEMENT PROCEDURES  
(PROJECT NO. PRO0734)

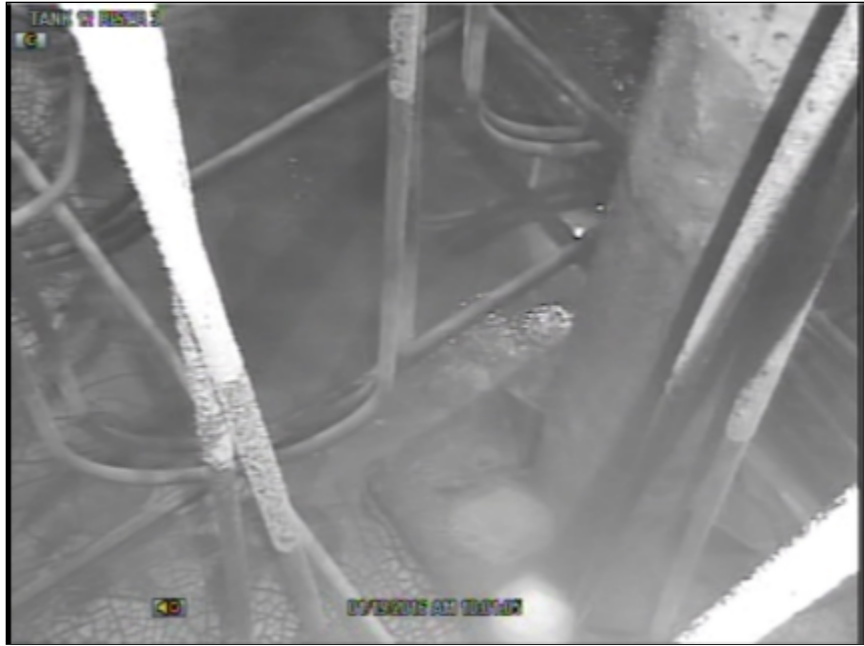
**Figure 1. Residual WIR on the Floor of the Tank 12H Primary Appears Similar to Mud Cracks. Light Reflects off a Pool of Water beyond the Column in the Bottom Image. Date of Video: January 19, 2016.**

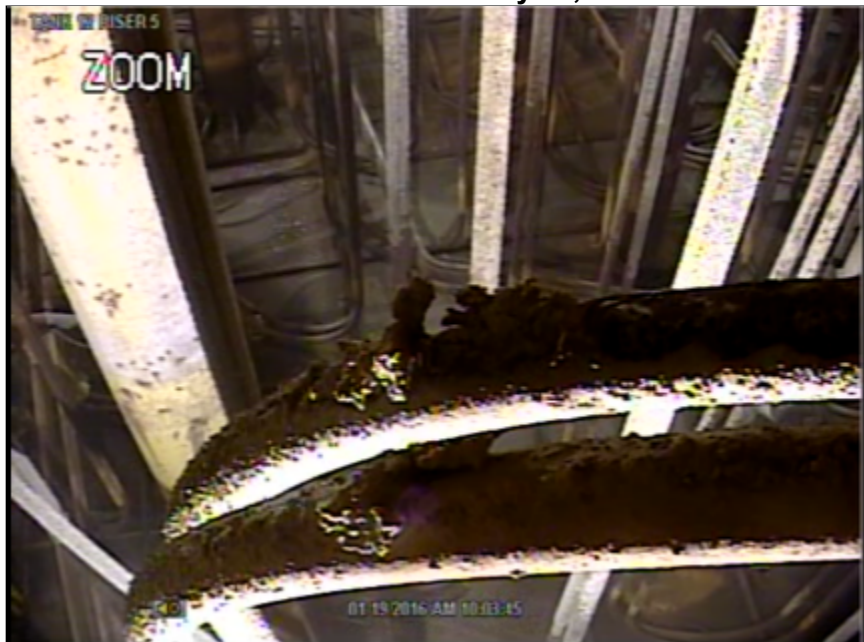
**Figure 2. Residual WIR on cooling coils within the Tank 12H Primary. Date of Video: January 19, 2016.**

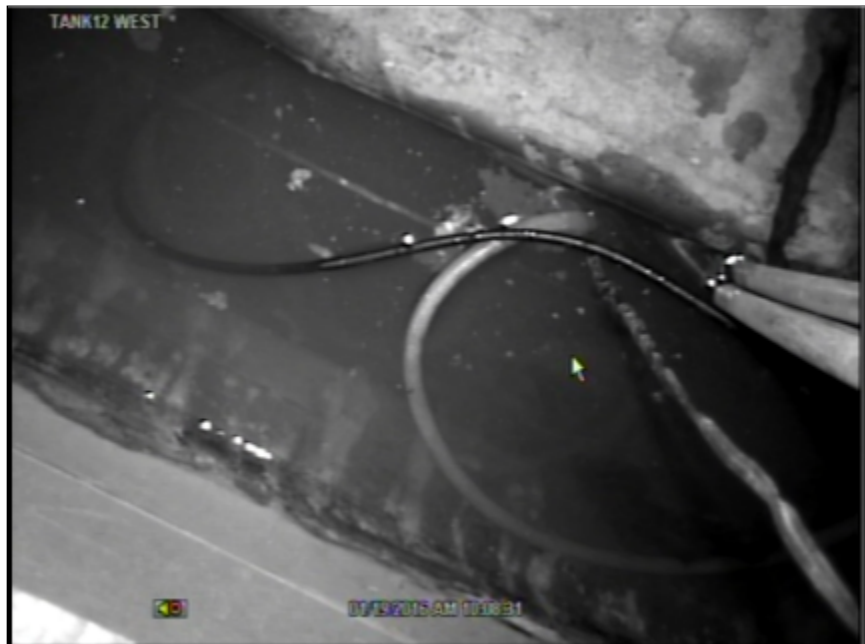
Placement of Lifts 2 and 3 in the Tank 12H annulus was delayed (ADAMS Accession No. ML16111B174) until 8 February 2016 (SRR-CWDA-2016-00068), due to groundwater accumulation in the annulus (**Figure 4**) when the temporary ventilation system, which forced unheated air through the annulus, was shut off (ADAMS Accession No. ML16167A237). As expected, groundwater accumulated in the annulus faster when air was “pulled” under negative pressure than it did when it was “pushed” with positive pressure (ADAMS Accession No. ML16167A237 and SRR-LWE-2015-00048). DOE estimated that ~3,785 L (~1000 gal) of groundwater was pumped out of the Tank 12H annulus (ADAMS Accession No. ML16167A237), reducing the water level to no more than 5 cm (2 in). Any standing water remaining in the annulus when grouting began likely would have enhanced bleed water segregation in Lift 2 (cf. RPT-5539-EG-0016, Test 2), leaving an as-yet-unquantified impact on the hydraulic conductivity of the bottom layer of grout (i.e., Lift 2) in the annulus (cf. SRNL-STI-2012-00576).

**Figure 4. Groundwater In-Leakage in the Annulus, as viewed from the West Riser.  
Date of Video: January 19, 2016.**
